STRUCTURAL ANALYSIS  
OF THE  
SOUTH MOORING DOLPHIN  
U. S. NAVCOMSTA  
H. E. HOLT  
EXMOUTH AUSTRALIA

FPO-1-85 (5)  
MAY 1985

OCEAN ENGINEERING  
AND CONSTRUCTION PROJECT OFFICE  
CHESAPEAKE DIVISION  
NAVAL FACILITIES ENGINEERING COMMAND  
WASHINGTON, D.C. 20374

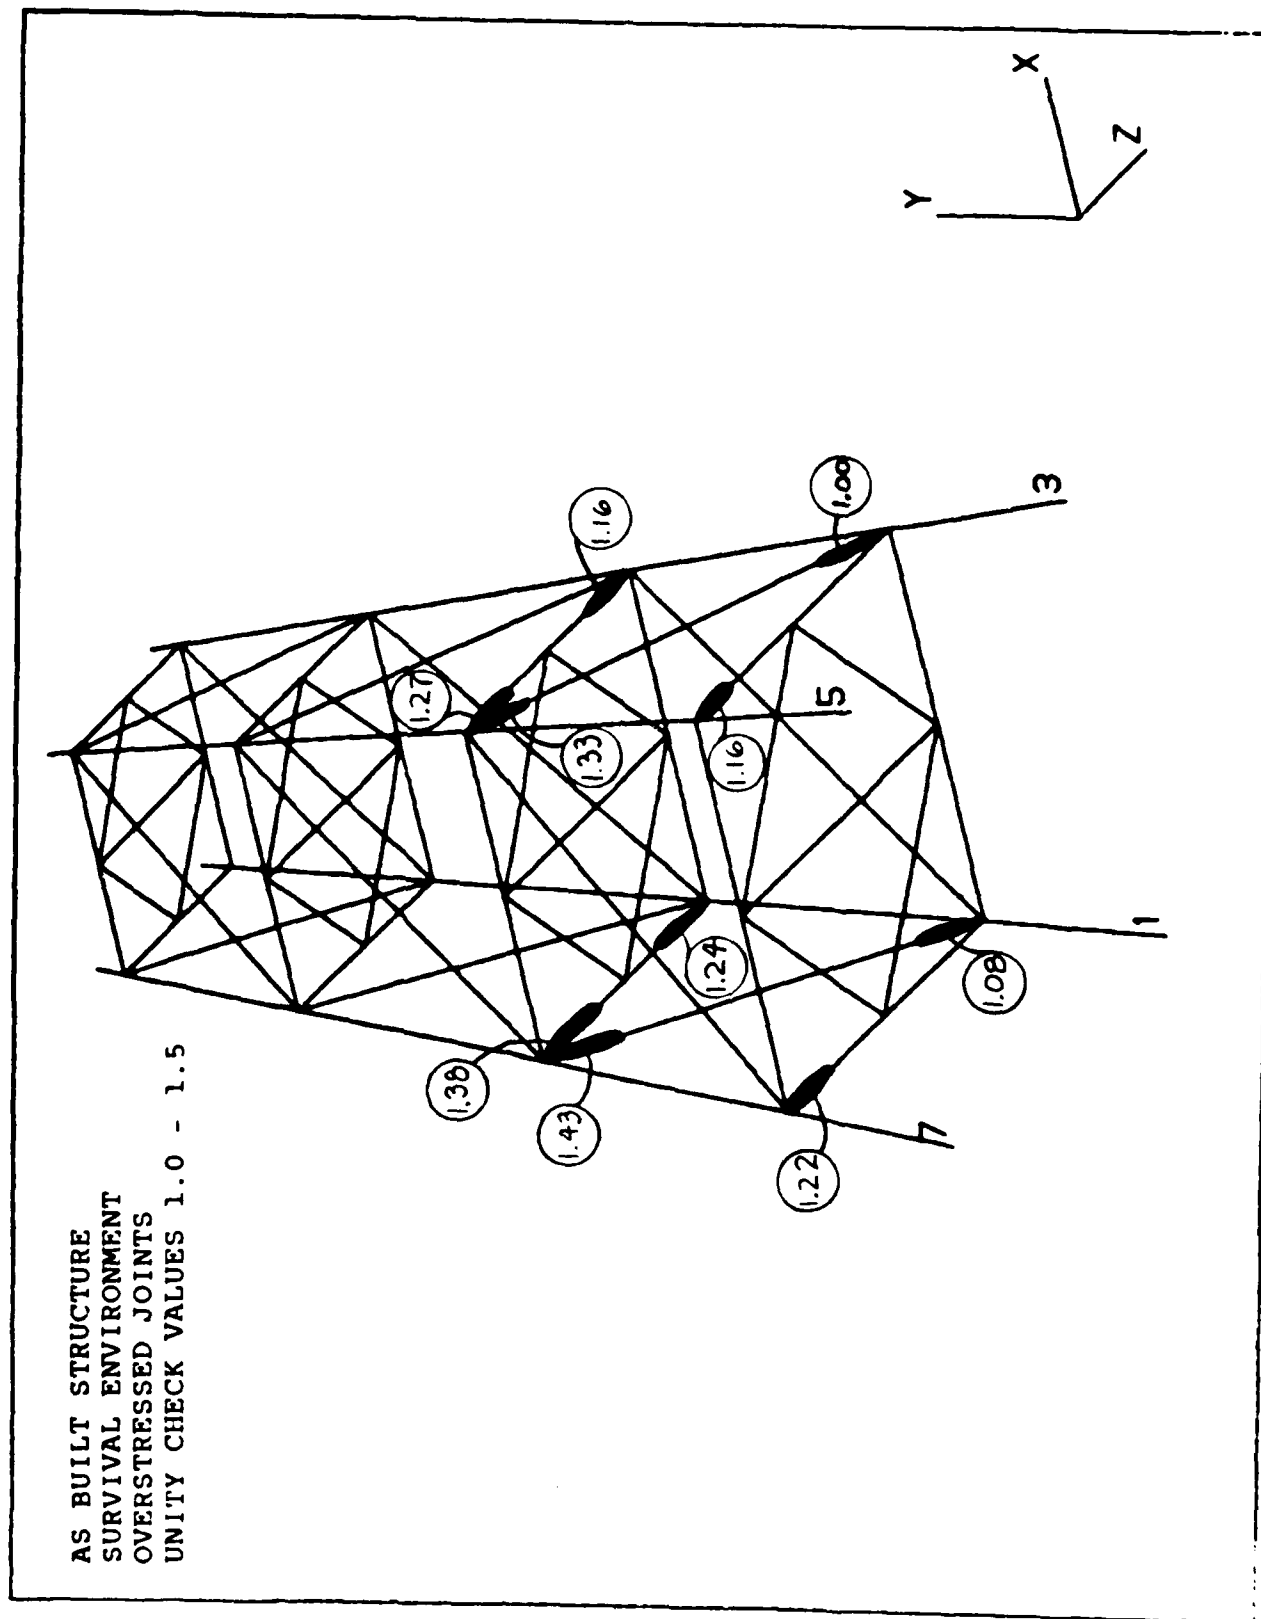
FIGURE 5-1

For the survival conditions, again no members were indicated to be overstressed. However JOINTCAN identified ten overstressed joints (unity checks values greater than 1.0). The location and magnitude of these overstresses is shown in figure 5-1. No joints were stressed to unity check values greater than 1.5.

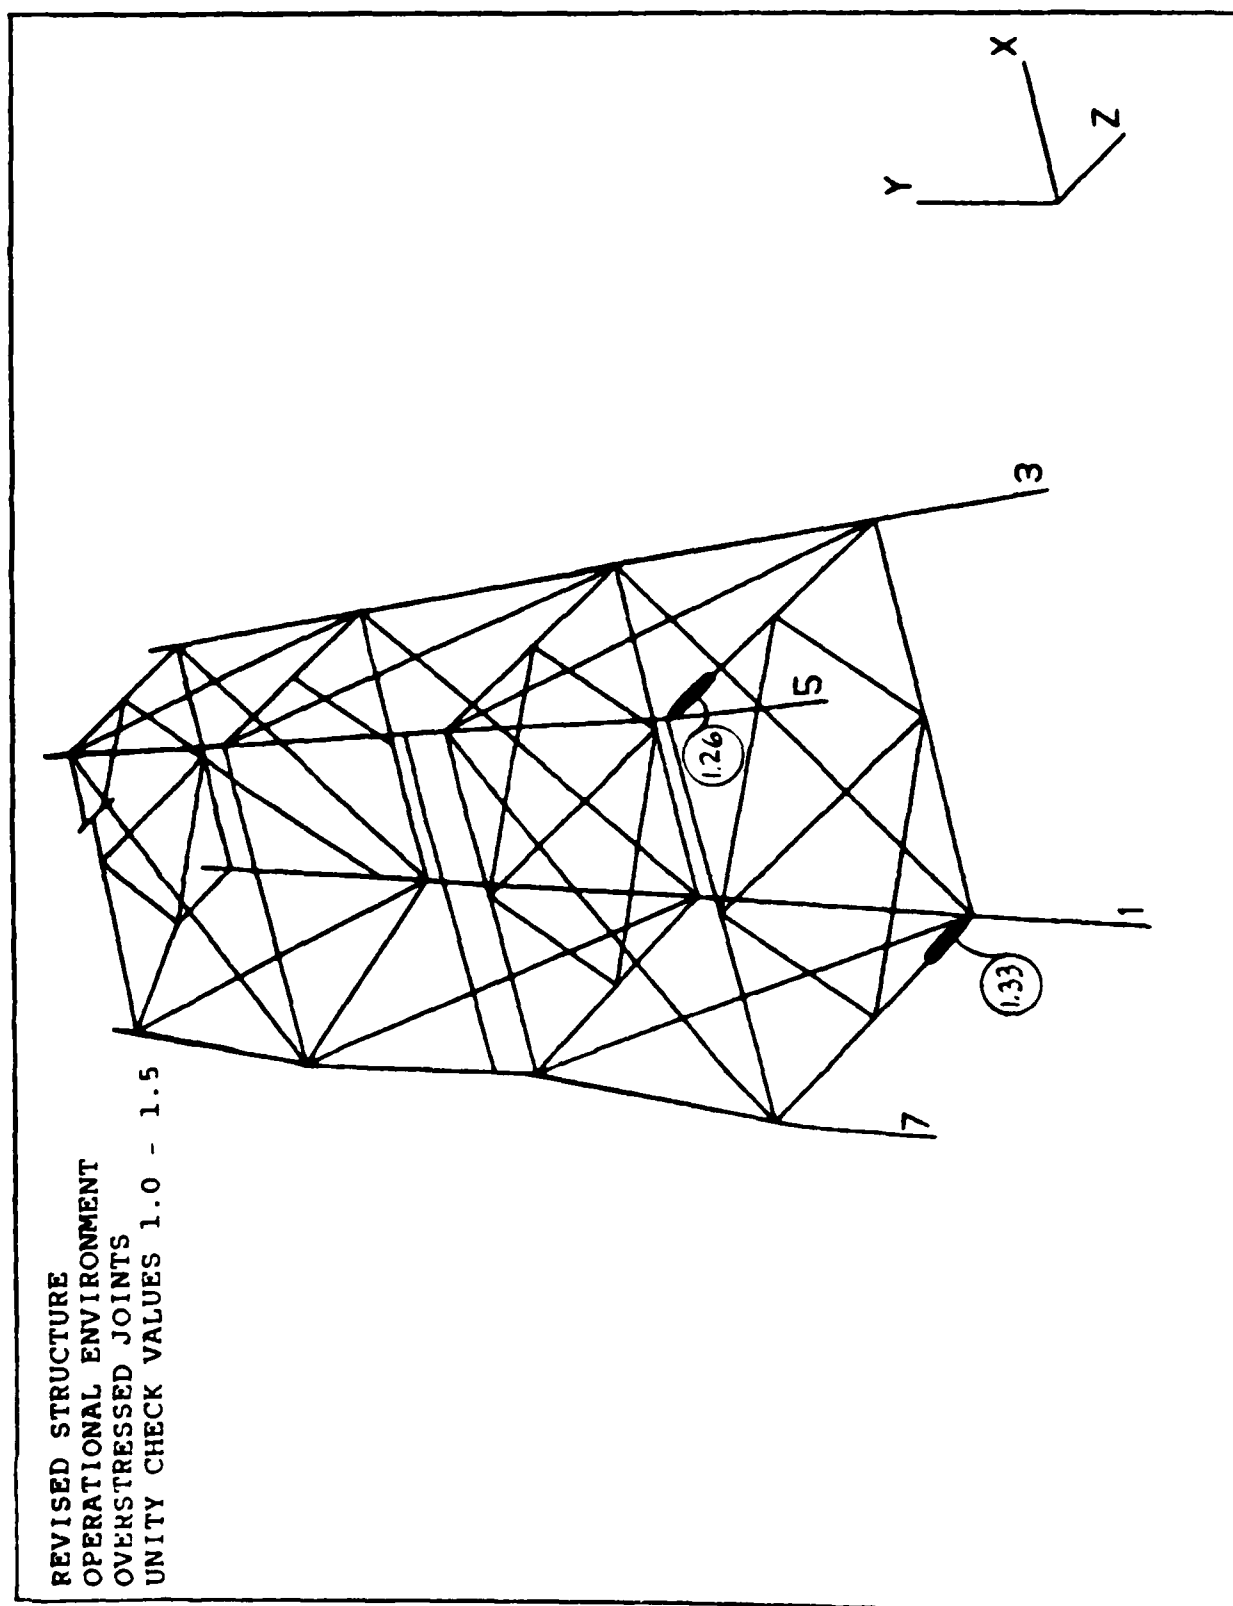
FIGURE 5-2

The revised structure also endures the operational environment without any overstressed members. The JOINTCAN routine found just two joints we can consider overstressed. Their location and degree of stress is shown in figure 5-2.

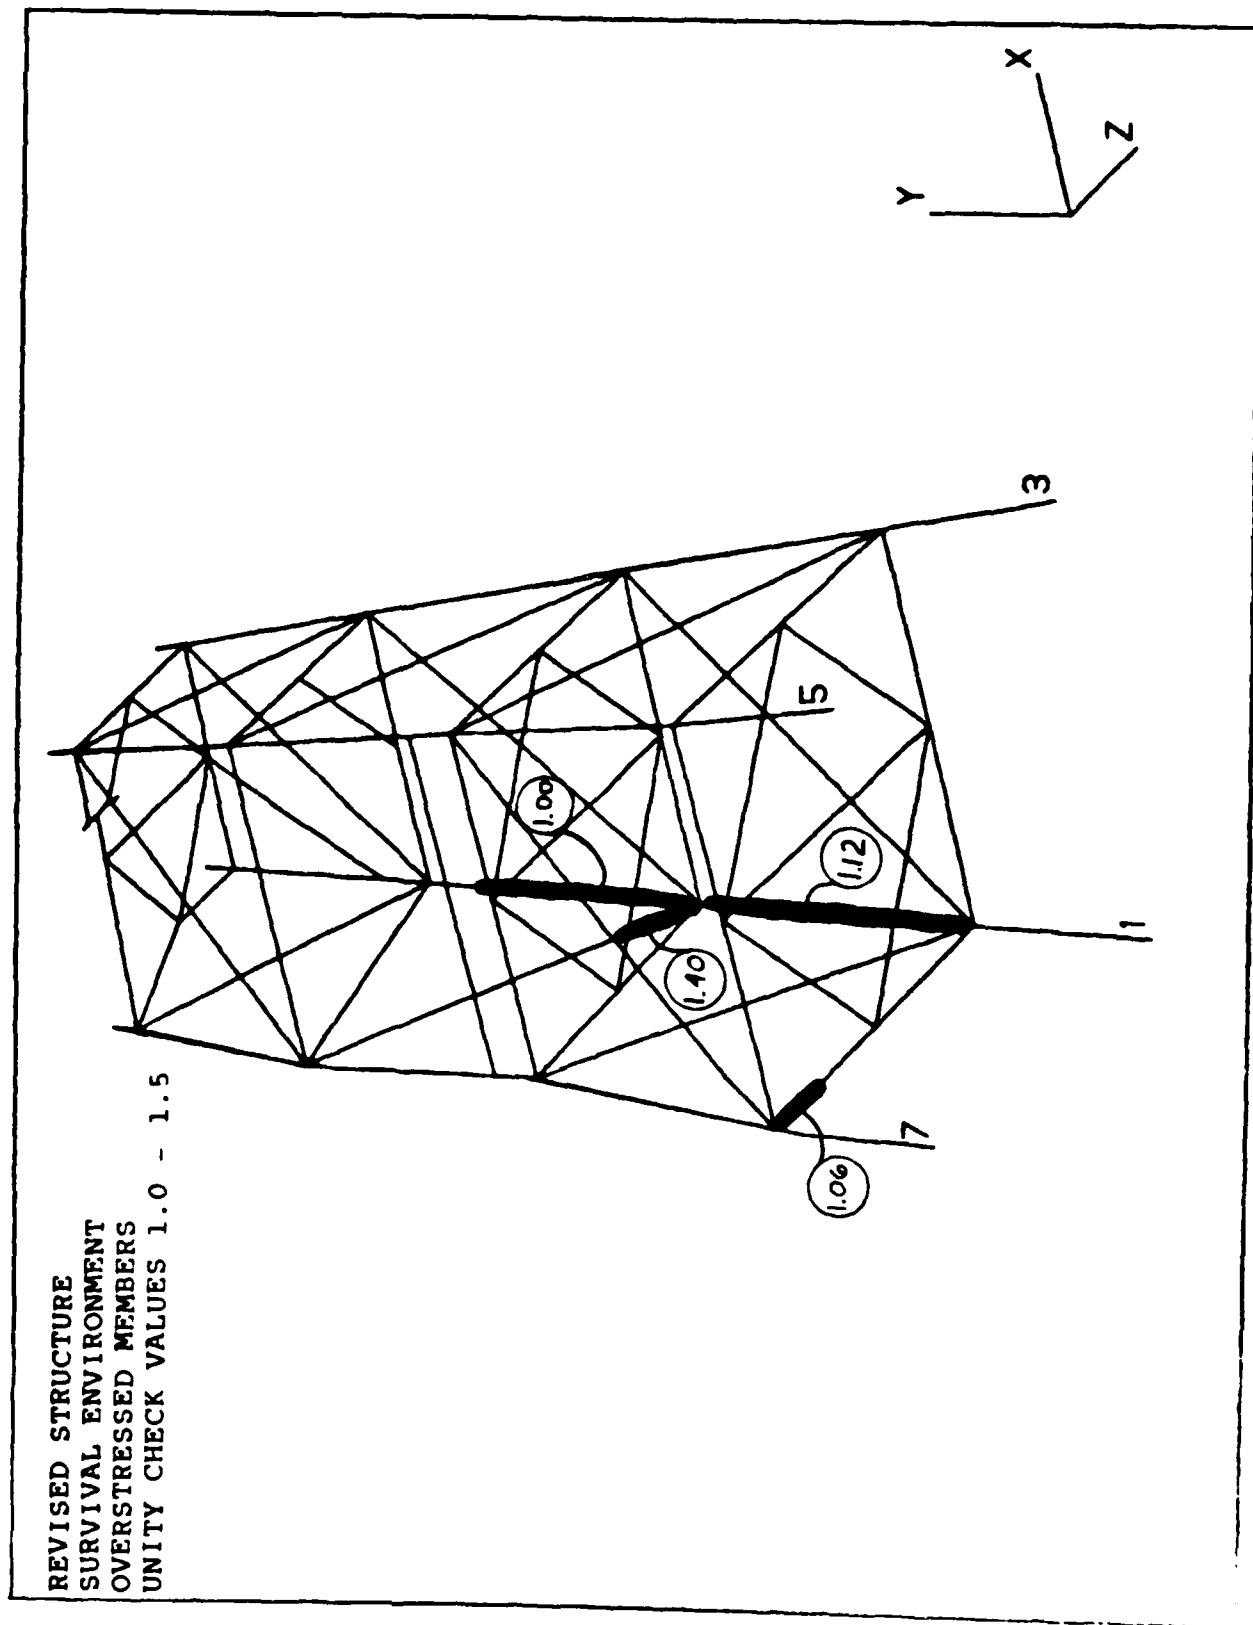
FIGURE 5-3

The survival environment induces far greater stresses in the revised structure than in the as-built. SACS identified four overstressed members in this harsh environment. The positions and unity check values of these over stressed members are shown in figure 5-3. None of the values are greater than 1.5.

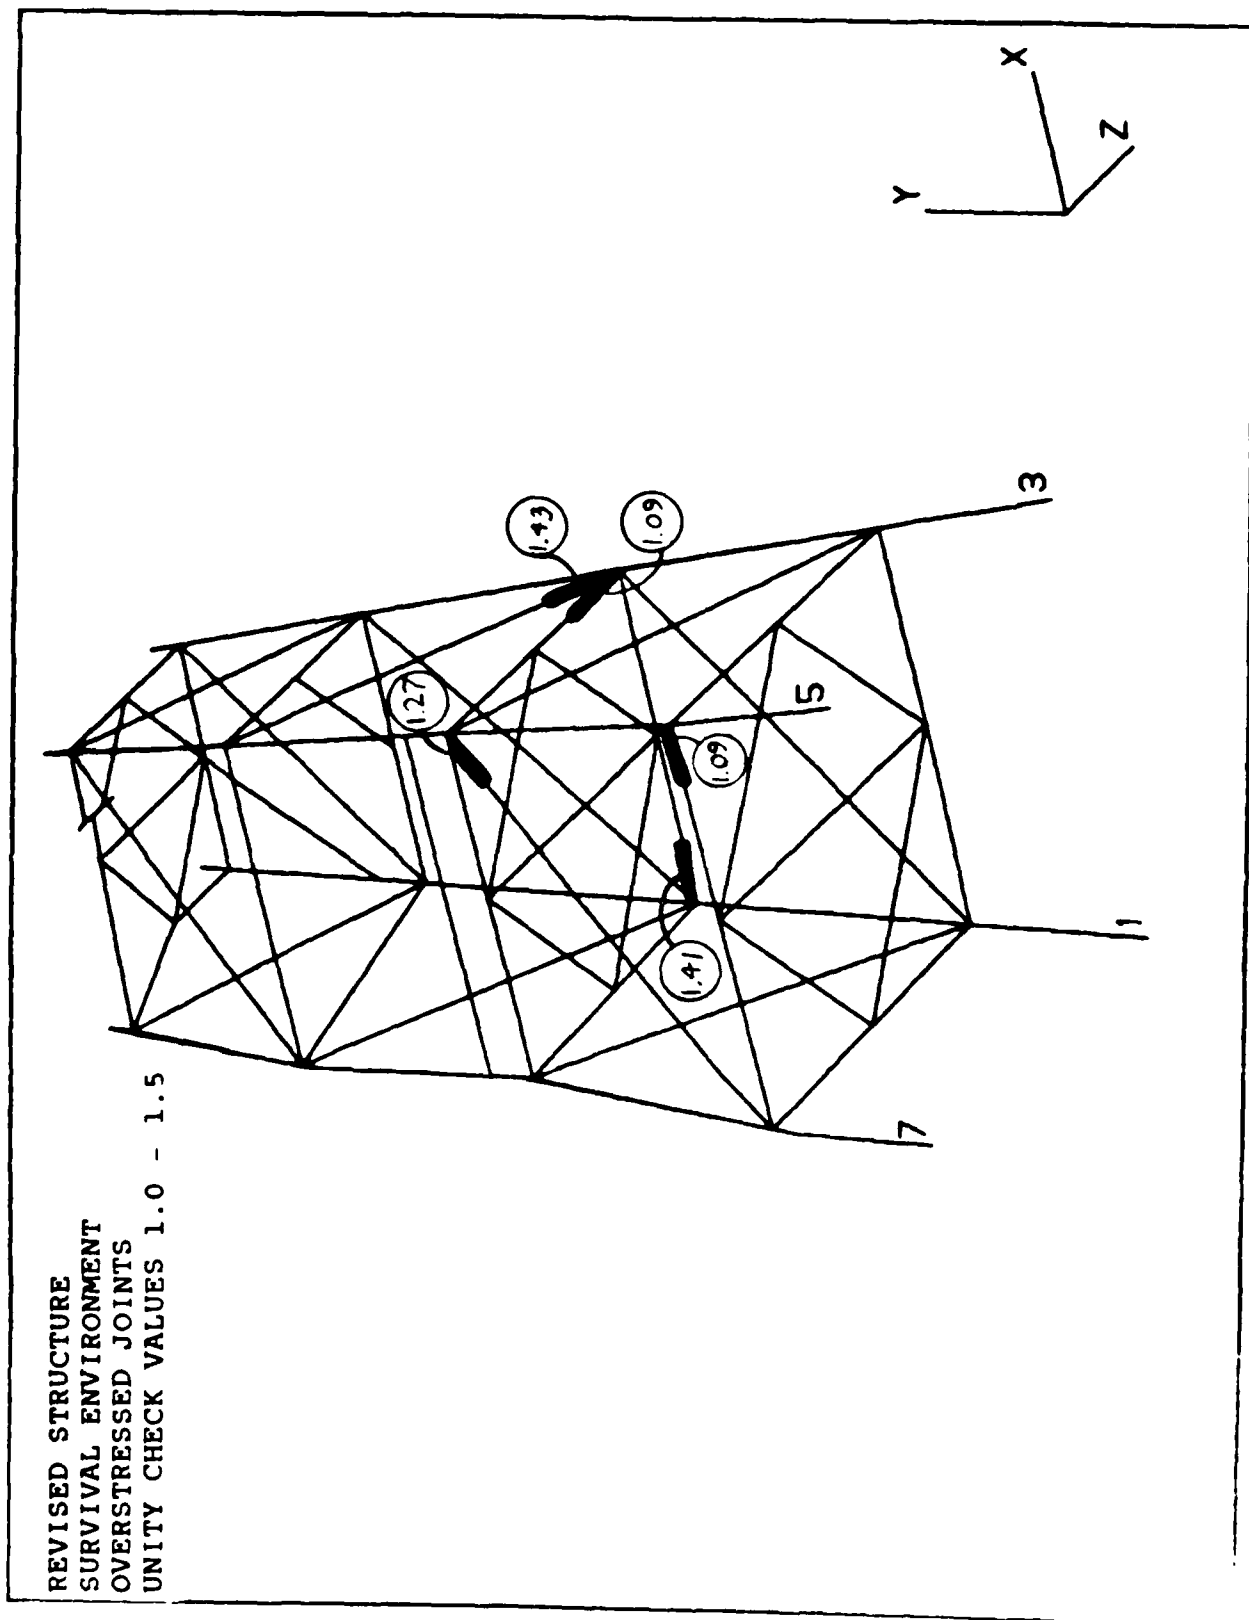
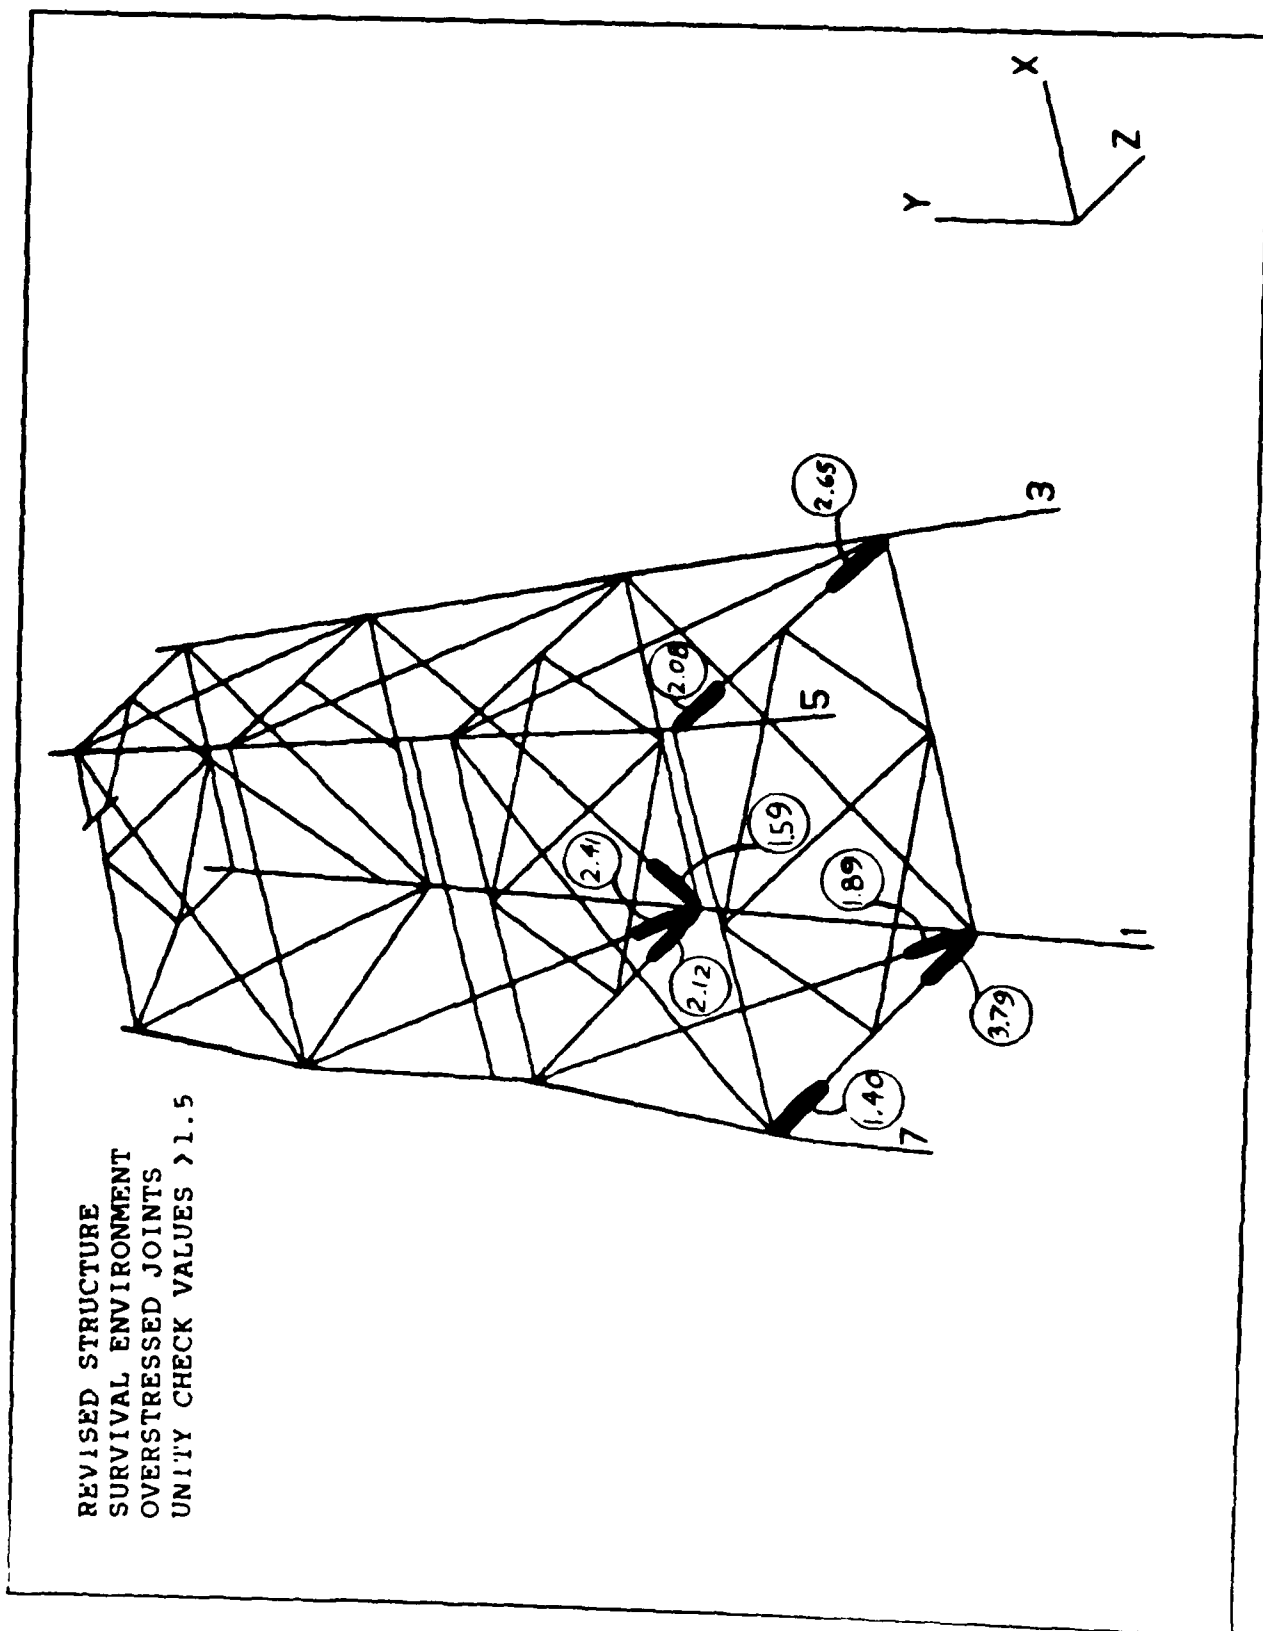
The revised structure has 13 overstressed joints in the hurricane environment. Five of these fall into the range of unity check values between 1.0 and 1.5. Eight have unity check values greater than 1.5; ranging to as high as 3.79. The locations of these overstresses and their magnitudes are shown in figure 5-4 and 5-5.

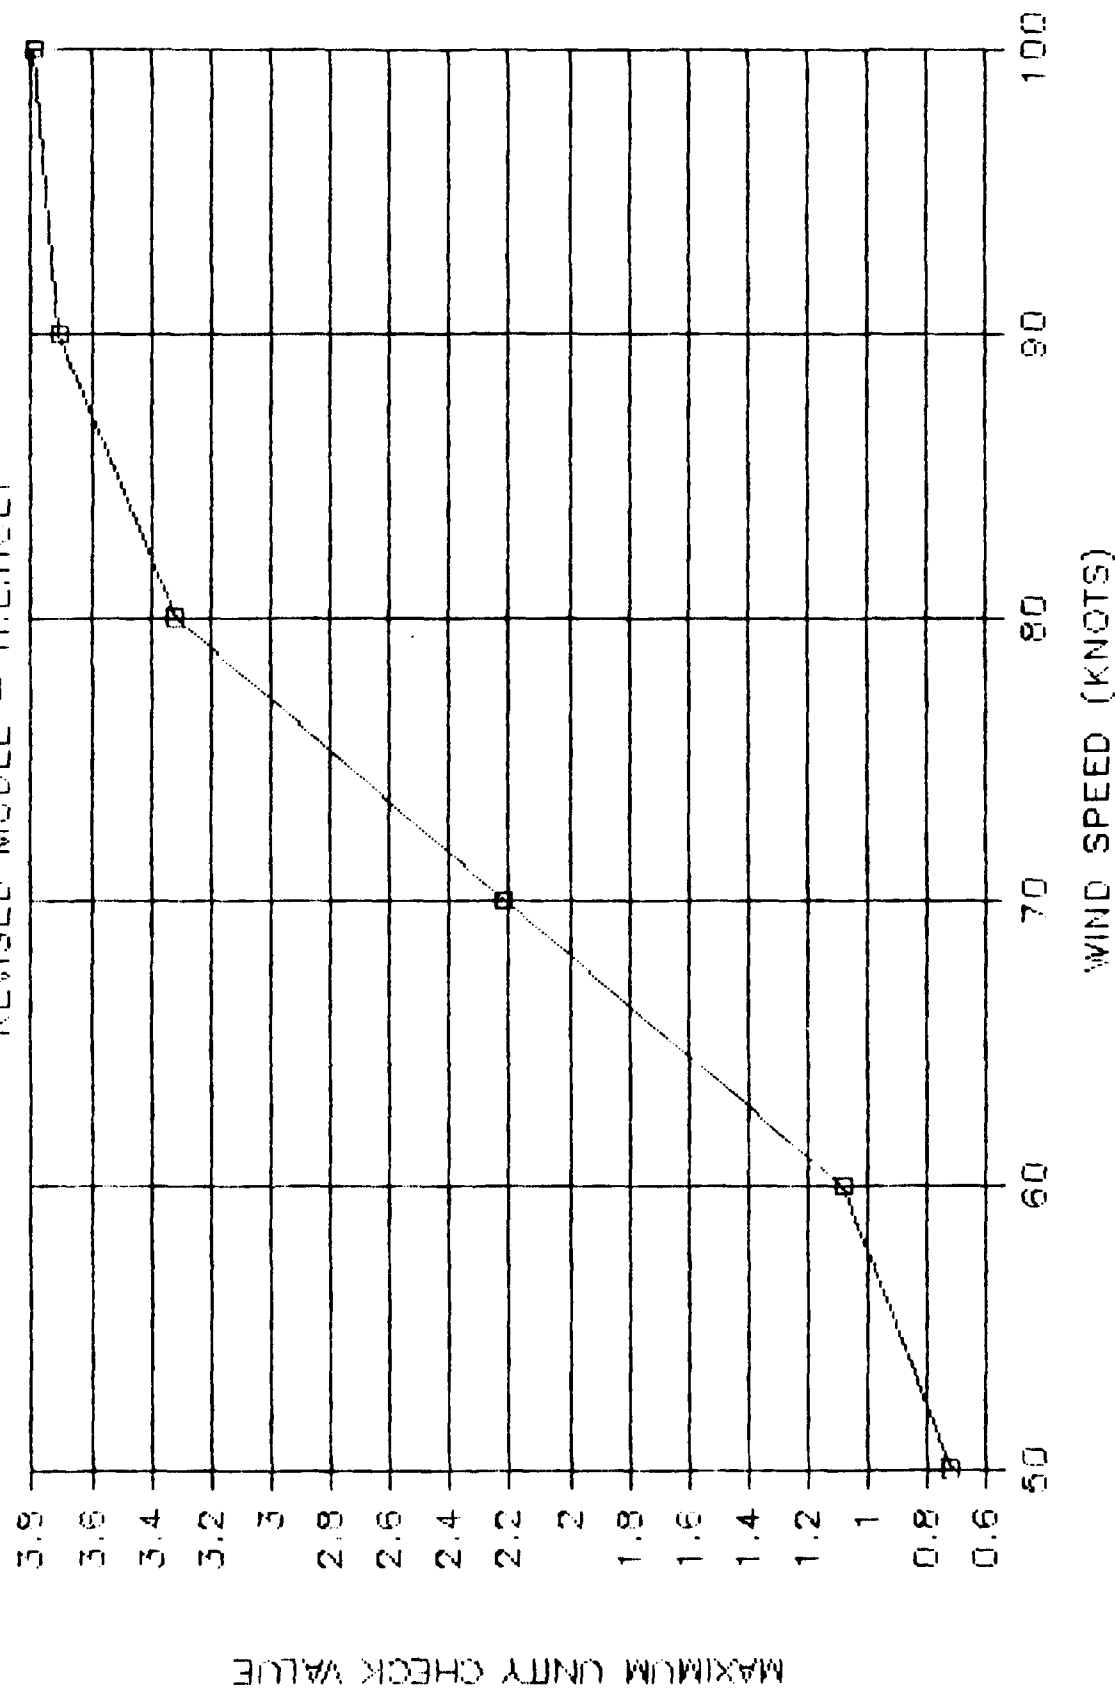
FIGURE 5-6

After determining that the dolphin would be overstressed in a hurricane environment, we sought to estimate the magnitude of a storm which would just start to overstress the structure's joints. We examined the structure's response to winds of 50, 60, 70, 80, 90 and 100 knots. Table 5-1 shows wind speed vs maximum unity check values for all of the structure joints. We observed from figure 5-6 that a storm with sustained 64 knot winds would stress at least one joint to a unity check value of 1.5 (indicating a failure).
